SHATTO DAM

SULLIVAN COUNTY, MISSOURI

MO 10068

PHASE 1 INSPECTION REPORT NATIONAL DAM SAFETY PROGRAM.

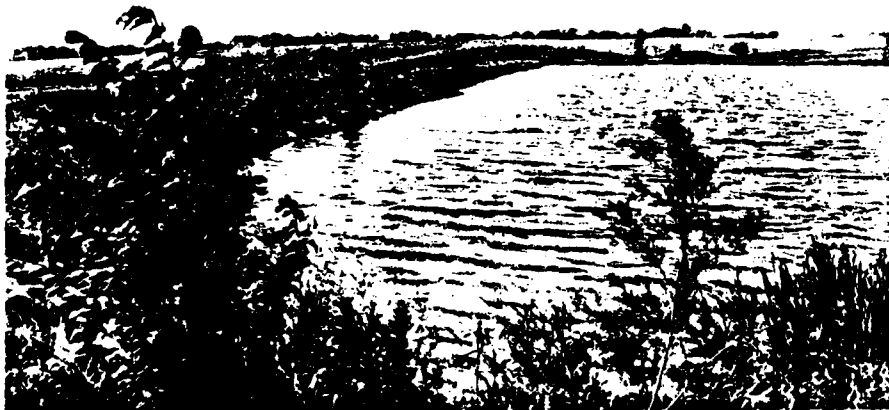
b. Dam. The riprap on the upstream face consists of durable limestone and looks good. There was no evidence of significant erosion or slips on the upstream slope. A couple of elm saplings, near the waterline, were observed toward the left (north) end of the dam. Some small willows were also observed around the principal spillway inlet area.

PHOTO. NO. 4
UPSTREAM SLOPE
TAKEN FROM NORTH
LOOKING SOUTH

a. Safety. The few small trees on the upstream face of the dam should be removed. Additional studies should be made to determine the source and affects on structural stability of seepage conditions observed on the downstream slope and toe of the dam. The probable maximum flood will overtop the dam. The spillways will pass the 0.36 PMF without overtopping.

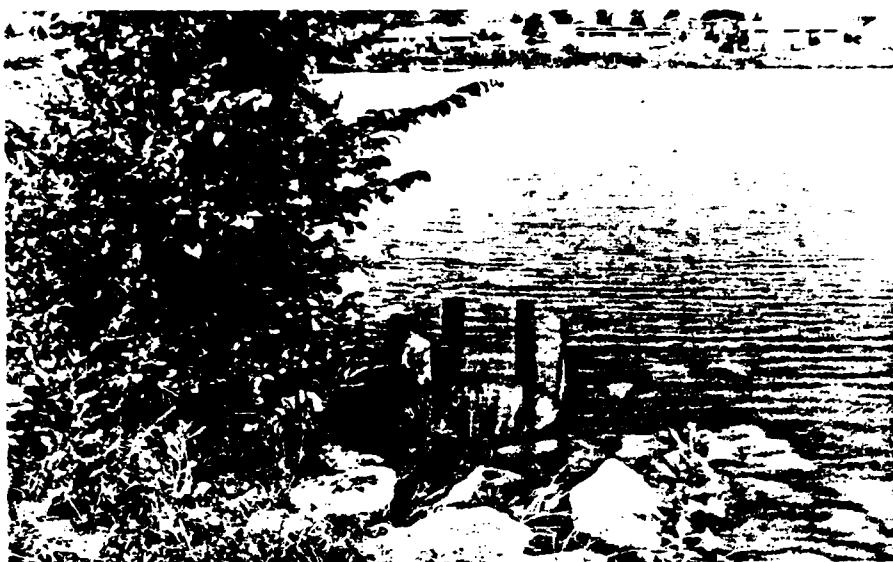
- (11) Foundation/Embankment Drains - no.
- h. Diversion and Regulating Tunnel. None.
- i. Spillway.
- (1) Principal
 - (a) Type - 48 diameter corrugated metal pipe inlet riser (See Photo No. 5) with wire mesh screen on crest and a 12 inch corrugated metal pipe conduit.

c. Appurtenant Structures. The principal spillway consists of a corrugated metal pipe riser, 4 feet in diameter and 4 feet in height, connected to a 12 inch diameter CMP outlet passing through the dam. The inlet pipe is covered with wire mesh. The outlet discharges into the natural drainageway about 1200 feet downstream from the dam (see plan view in Appendix C). Water to a depth of about 2 inches was flowing over the crest of the spillway at the time of the inspection. There was no visual evidence of deterioration of the principal spillway.

PHOTO. NO. 5
48" DIAMETER CMP
SPILLWAY ENTRANCE
